Kettlebaston Roadside Verge Erosion Survey, 2007 - February 2011 Update

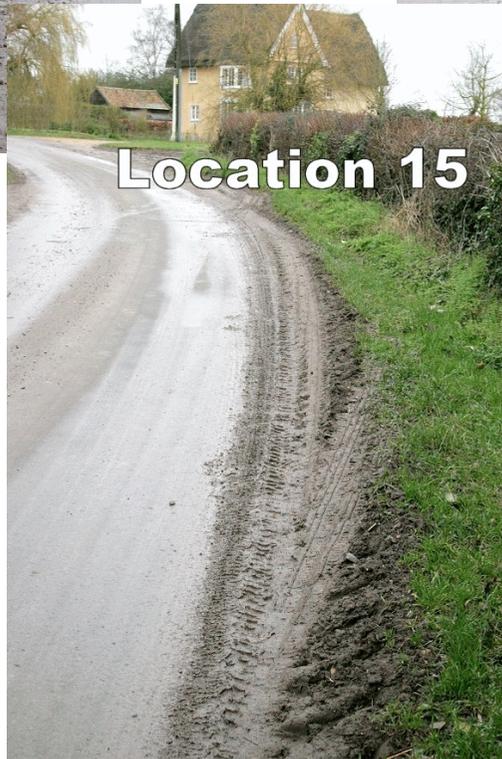
Location 15

- Several unofficial passing places are evolving. This is particularly notable at locations 2 (downhill of Evans Corner), 15 (beside Stone Cottage & opposite Church House), and 18 (just beyond Dockyard). Additionally, damage to the 'village green', opposite the stud entrance and Durley's front lawn were noted this spring. Increased erosion was also evident along the bank opposite Evans Corner where lorries / tractors have caused impact damage (usually avoiding other vehicles).
